Evaluation of Subgrade Soil on Premature Failure of Flexible Pavement in Hilly Area of Mizoram, India

H Laldintluanga^{1*}, Rebecca Ramhmachhuani¹, Lalramtiami¹¹ Department of Civil Engineering, Mizoram University, Aizawl, Mizoram, India

Objectives: Subgrade soil has played an important role in the premature failure of, especially flexible pavement in a hilly area where rainfall intensity is very high. Even a slight failure in subgrade will reflect on the structure of the pavement in terms of cracks, undulations and rutting. An attempt has been made to find the influence of subgrade soil on the premature failure of the road along the State Highway which connects the lifeline between North and South of Mizoram, India. **Methods:** The locations where early deteriorations took place were located and testing was performed to assess the value of atterberg limits, permeability, bearing capacity, free swell index and hydrophilic coefficient. **Findings:** Premature failures of pavement are highly influenced by the emanation of groundwater in the form of spring along the hilly side of the road. The deep cutting of the road is not suggested due to the possibility of encountering water se

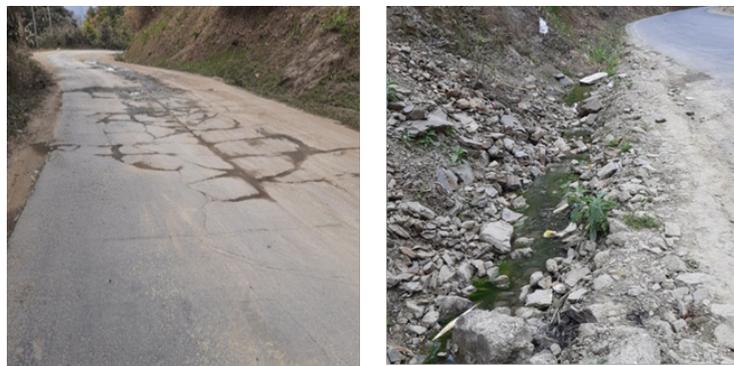
Even during the dry season (March), there is still water seepage on the surface of the pavement at Pukpui, Hualngo as shown in Figure 2. Since the pavement is fully saturated even during the dry season, it will weaken the pavement structure as soil tends to lose strength when fully saturated with water. It is necessary to lower the water table in this section and to provide good drainage so that the water can drain off quickly.

The Pukpui stretches have a layer of shale rock that is considered impermeable. A layer of impermeable material prevented the water from further propagating downward. Impermeable layers prevent water from flowing further downward, making an unconfined aquifer that leads to pavement collapse.

Fig 2. High water table

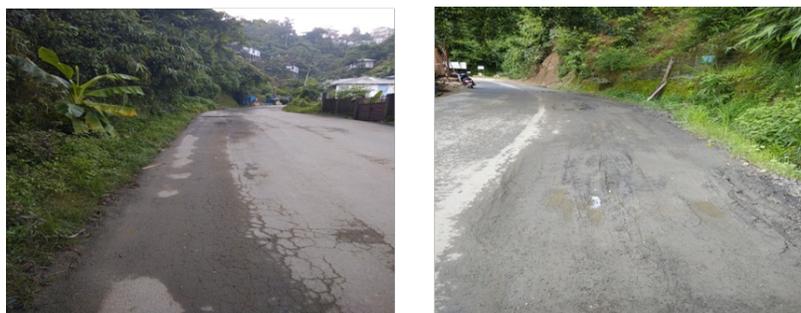
Pavement geometry includes carriage width, alignment, sight distance, shoulder, side drain, curve, camber, and gradient. The 35-year average rainfall of Mizoram is over 2000 mm which has a significant impact on subgrade softening if surface and sub-surface drainage is poor. The rainy season (monsoon) lasts for at least four months (June-September) and contributes about 70 percentage of total annual rainfall. The road with a high shoulder delays the surface runoff of water due to poor surface drainage as shown in Figure 4. Delay water saturates the subgrade by entering the shoulder from the edge of the pavement.

Fig 4. Raised shoulder & tall grass blocking surface drainage
