Road Safety Audit and Comparison with Accident Case Studies

K. Durga Abhishek, K. Yogesh Kumar, and R. Vijayalakshmi*

Abstract

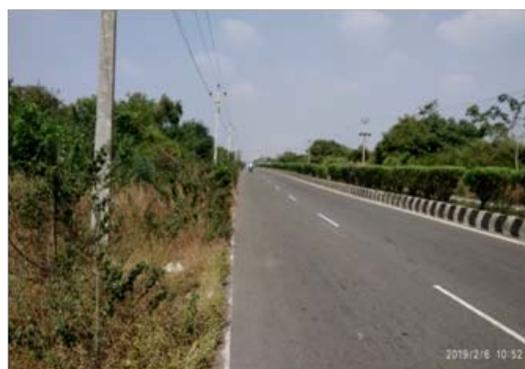
(a)

Problem 1: Growth of vegetation on the road sides

IRC Code Violated: IRC SP 021: Guidelines on Landscaping and Tree Plantation As per the IRC code IRC SP 021, From Clause 10.3, it states that

Selective pruning or cutting of trees and shrubs will be required at situations where these

- i. interfere with sight distance,
- ii. come in the way of effective street illumination,
- iii. are too close to the carriageway so as to be hazardous

The news article states that, a motorcyclist died when he rammed into a stationary lorry near Vengambakkam bus stop on Vandalur – Kelambakkam Road. The lorry was parked on the road side after one of its tyre punctured. From the article, it is observed that the lorry was parked on the road lane either due to unavailability of shoulder width or growth of vegetation on the shoulder (Figure 5a). This is a serious problem for road users both in day and night time (Figure 5 b).

Figure 5. IRC codal violations. a. Growth of vegetation. b. Interference with sight distance.

Solution to the problem: Growth of vegetation on the road side has been a serious issue in the road safety process and the maintenance of the growth should be done

periodically. Hence various other measures can be taken to reduce the growth of vegetation on the road sides. Some of the measures are, (i) Herbicides can be used in management of annual and perennial, herbaceous vegetation in field and roadside plots (ii) Ornamental plant species which have aesthetic value and pollution tolerance are recommended for planting along the roads. The Conclusion for the problem is to properly maintaining the vegetation growth on the sides. Hence the maintenance of growth of vegetation on the road side should be considered as a serious issue and has to be maintained periodically as per the IRC SP 021.

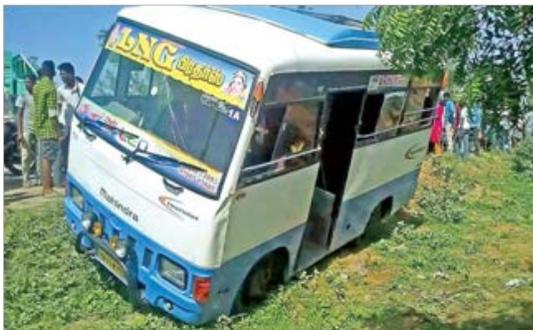
(a)

Accidents Occurred: Class VII girl crushed to death under her school van- The New Indian Express. The news article states that, A Class VII student died and her younger sister and eleven other children suffered injuries when a van overturned on the Vandalur - Kelambakkam road. The accident occurred due to, the driver tried to overtake a speeding lorry. While doing so, he drove over a pothole and lost control of the vehicle. The sisters seated right next to the door were thrown out and Nethra was run over by the van's rear tyre. The van overturned off the road, injuring all the children inside.

Figure 6. Accident occurred due to difference in level of road and shoulder. a. Road Accident. b. Shoulders and road level not equal.

Solution to the problem: Maintaining of shoulder level with the road level is very much important since that space acts as the parking space in highways. Hence the following measures can be taken to maintain the road level and the shoulder level.

1. Proper earth material should be filled up in the shoulder after the laying of a new road.
2. Guard rails should be provided in the curves of roads in order to avoid the overtopping of vehicles to the side.

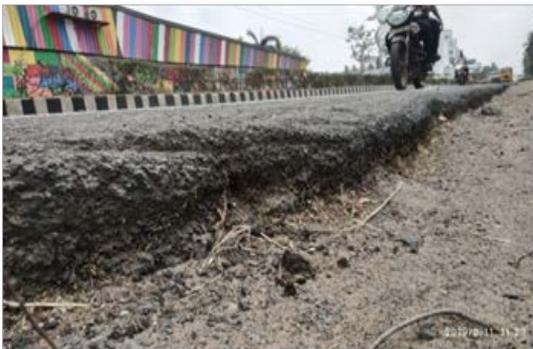
(b)

Problem 2: Shoulder and road level is not equal and side barricades are not available

1. As per the IRC 086 clause 8.3, the road level and the shoulder level should be equal. But in many places throughout the stretch, proper shoulder width is not provided and the shoulder and road level are not equal.
2. As per IRC SP 84, proper guardrails should be provided in curves of highways. In this case, guardrails are not provided.

Conclusion for the problem is, by properly maintaining the shoulder level and the road level two wheeler accidents and vehicle roll over problems can be reduced. Increase shoulder widths can be used as parking area as shown in Figure 6.
