# A Multi-Approach Investigation of Tlawng River Flood Hazard in Sairang, Mizoram

**Citation:** Lalremruati, Lallawmsanga, Lalhmingangi, Ralte Z, Laldinpuia (2023) A Multi-Approach Investigation of Tlawng River Flood Hazard in Sairang, Mizoram. Indian Journal of Science and Technology 16(SP1): 148-157. <https://doi.org/10.17485/IJST/v16sp1.msc21>

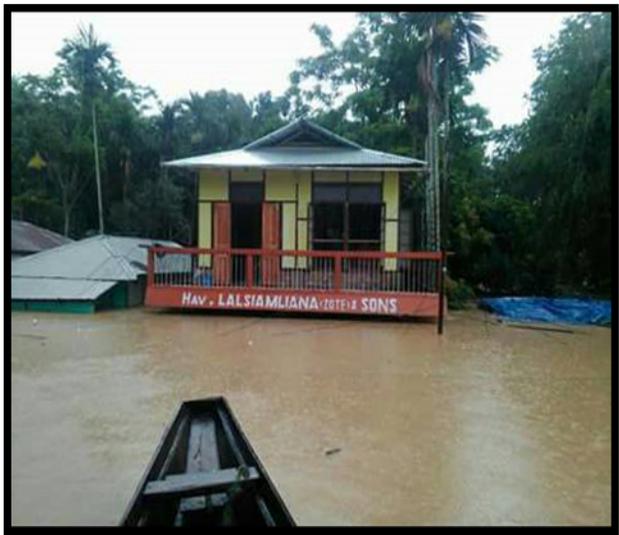
Fig 4. 2017 Flood innundated house, Sairang

As settlements were clustered in close proximity to the river, several houses were inundated where 15 houses were evacuated. Since water seep into the earth, cracks were developed in most inundated houses. Meanwhile, the flood prone must be restricted for settlement<sup>(17)</sup> and other several constructions to minimize the loss and destruction. However, regardless of the vulnerability, those houses were normally occupied again soon after. The reason to these circumstances are absence of restriction and land-use regulations and too; low economic status to quest and rebuild a new dwelling.

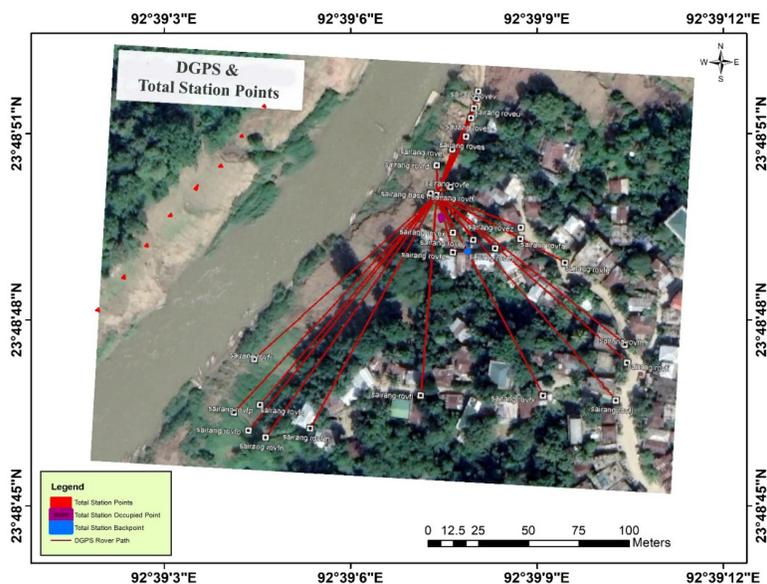
Fig 7. DGPS and Total Station points

The current river line on the right bank of the river was observed using DGPS. The left bank was inaccessible due to flood, where Total Station survey was performed effectively in collection of point along the imprint line of flood elevation. The flood has reached up to an elevation of 104m on 18<sup>th</sup> June 2022. It was detected that water has receded from 104m to 61m from 18<sup>th</sup>-22<sup>nd</sup> June 2022. The decrease amount of rainfall in the area being the chief reason which has led to the speedy receding of the flood level.

During the flood in the year 2022, the right bank of the river line was detected using Differential Global Positioning System (DGPS). The left bank was inaccessible due to high level of flood. Owing to that problem, Total Station was employed to perform the same as the right bank. A total of 31 longitudinal points indicating the coordinates and elevation were taken along the current river line and the edge during the highest flood level<sup>(8)</sup>.

On 18<sup>th</sup> June, the river Tlawng was flooded at an alarming rate and two houses were evacuated. An experimental survey was conducted on 22<sup>nd</sup> June using Total Station and Differential Global Positioning System. The utilization of total station has become efficient and convenient in study of hydrological process<sup>(8,21)</sup>. Collecting points of desirable location can be performed through DGPS survey<sup>(22)</sup> and river line survey using Total Station<sup>(8,22)</sup>.
