Biodegradation of paints: a current status

H.R. Ravikumar¹, Shwetha S. Rao² and C.S. Karigar^{2*}

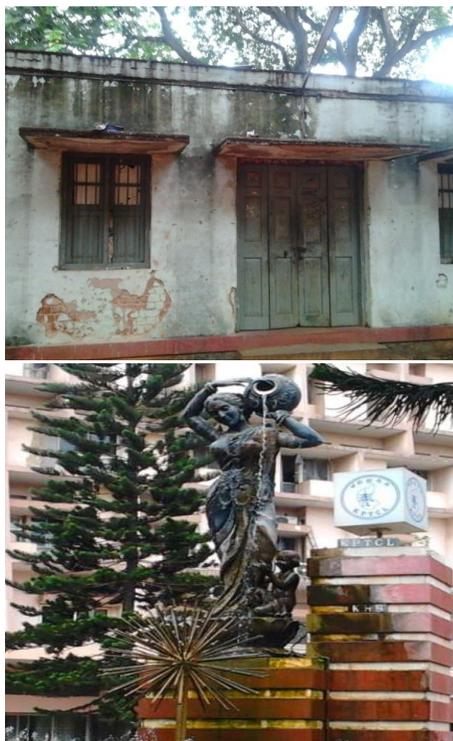
Fig.1. Biodeterioration of domestic and public buildings. Biodegradation of paints

production of 'off odors') have also been attributed to microbial contamination. Films of oil- and water-based paints are colonized by micro-organisms on the outside and inside of buildings (Fig.1). This aspect of biodeterioration can be both unsightly and hazardous to health. (Morton 2001). "Biodegradation" is the biologically mediated breakdown of chemical compounds. It is an umbrella term, encompassing most of the other jargon addressed in this section, and generally implies a series of biochemical reactions. When biodegradation is complete, the process is called "mineralization," i.e., the total breakdown of organic molecules into water, CO₂, and/or other inorganic end products (Alexander 1981).

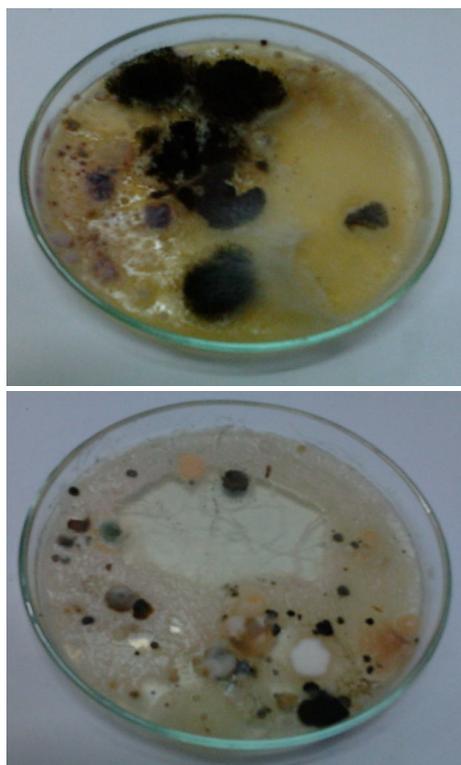
Fig.2. Spoilage microorganisms cultured from domestic building surfaces. Paint spoilage microorganisms

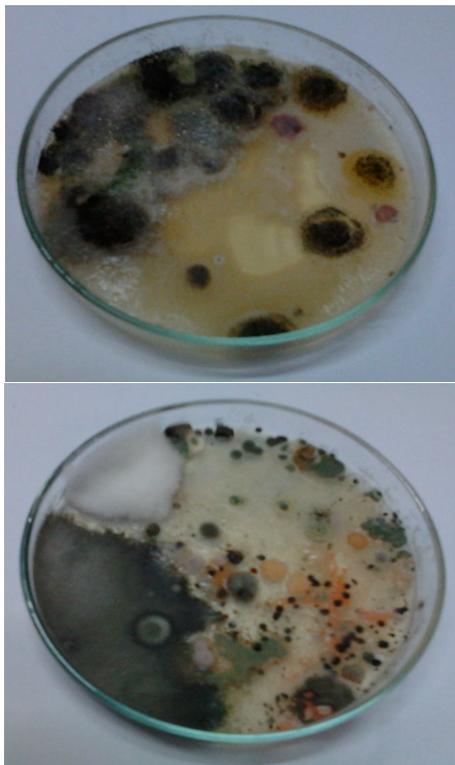
Fig.3. Spoilage microorganisms cultured from public building surfaces

The effects of such growth are initially disfigurement of the surface followed by breakdown of the coating and decay or corrosion of the underlying substrate. The growth of photosynthetic organisms is rare on interior surfaces but fungi, Actinomycetes, Cyanobacteria and Algae are all able to colonize exterior painted surfaces (Gaylarde & Gaylarde 2005). Although several groups of workers in the 1960s recognized that algae can produce organic acids which may be corrosive to some coatings, the main effects of algal growth are aesthetic the disfigurement premature redecoration (Fig.3 & 4).

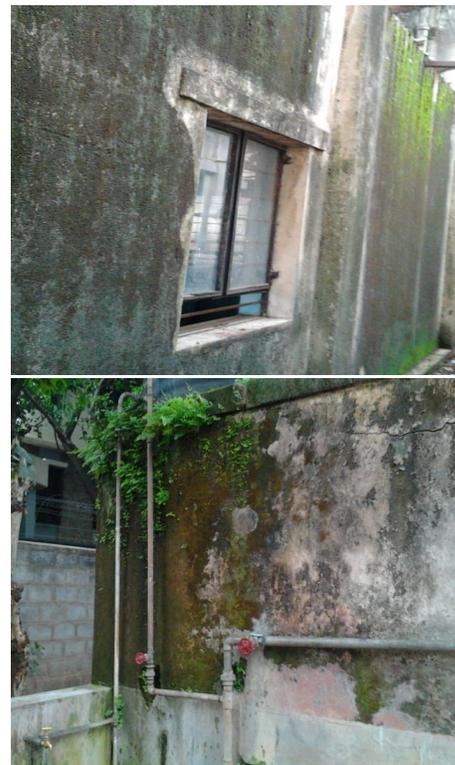
Fig. 4. Microbial activity on domestic buildings
