Evaluation of Subgrade Soil on Premature Failure of Flexible Pavement in Hilly Area of Mizoram, India

H Laldintluanga^{1*}, Rebecca Ramhmachhuani¹, Lalramtiami¹¹ Department of Civil Engineering, Mizoram University, Aizawl, Mizoram, India

Objectives: Subgrade soil has played an important role in the premature failure of, especially flexible pavement in a hilly area where rainfall intensity is very high. Even a slight failure in subgrade will reflect on the structure of the pavement in terms of cracks, undulations and rutting. An attempt has been made to find the influence of subgrade soil on the premature failure of the road along the State Highway which connects the lifeline between North and South of Mizoram, India. **Methods:** The locations where early deteriorations took place were located and testing was performed to assess the value of atterberg limits, permeability, bearing capacity, free swell index and hydrophilic coefficient. **Findings:** Premature failures of pavement are highly influenced by the emanation of groundwater in the form of spring along the hilly side of the road. The deep cutting of the road is not suggested due to the possibility of encountering water se

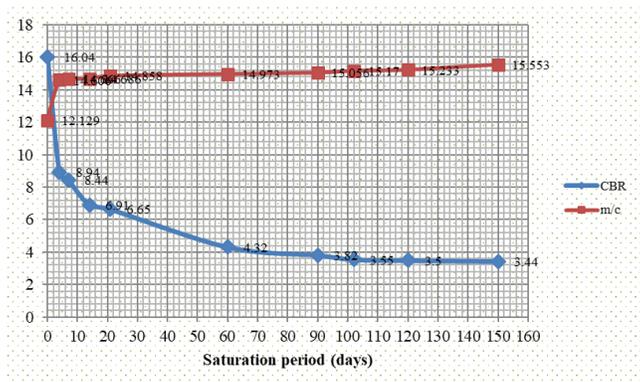
Fig 3. Effect of moisture in soil strength

It is observed that the CBR value of the soil sample prepared at a particular density decreases rapidly after 4 days of soaking. The rate of decrease of CBR value beyond 4 days soaking is minimal. It is also observed that there are not much significant variations in CBR values from 90th day of soaking. The soil strength reduces as the water saturation period of soil increases as shown in the Figure 3. Subsurface moisture reaches lower layers of pavement from different sources like pavement surface, seepage from shoulders and seepage from adjoining hills and capillary rise of moisture from the ground. If water is able to enter the pavement, there must be a way for it to depart. Soil resistance to compression may drop substantially if its moisture content increases. Increased moisture content reduces the load-carrying capacity of the road and causes premature pavement failure, resulting in shorter pavement life.

It was conceivable that the build-up of moisture in the subgrade would ultimately lead to its degradation under vehicular load and this was evident from the localized appearance of rutting and depressions at several locations. In a few cases, substantial accumulation of water had led to the puncturing through of the sub-base layer and complete failure of the subgrade.
