# Road Surface Crack Detection using Wavelets Features Extraction Technique

Slamet Riyadi<sup>1\*</sup>, Fiddin Yusufda A'la<sup>1</sup>, Chayadi Oktomy<sup>1</sup> and Kamarul Hawari Ghazali<sup>2</sup>

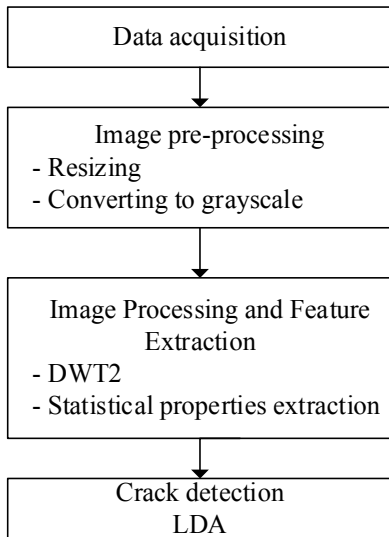
Figure 1. Crack detection diagram.

The methodology of the research is described in Figure 1. Firstly, to get the images data, we have to make data acquisition. Then the data was resized and converted to grayscale image. After that, images are processed and extracted using statistical properties extraction. This

study used mean and standard deviation values as statistical properties extraction. Finally, the linear discriminate was applied to classify the images as “crack” or “non-crack”. Discriminate lines make images separated by its class. This result was then compared to visual initialization images to get the percentage of accuracy.

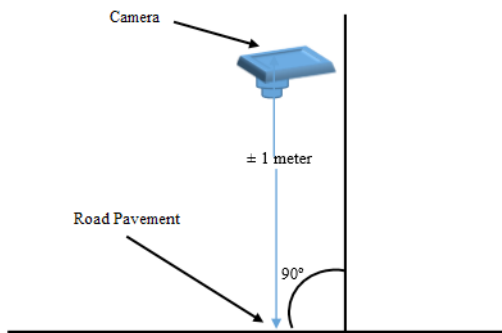
Figure 2. The image acquisition setup.

Figure 2 shows the image acquisition setup according to the following protocols:

- The camera was positioned in perpendicular view to the road.
- Camera and road surface distance should not be too close or too far so the image obtained can be processed well.
- Data was collected at certain hours when it is not too dark and have enough light intensity.

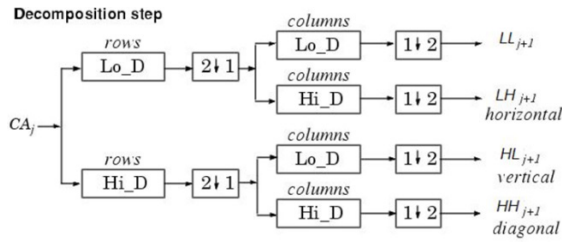
Figure 4. Decomposition step.

If an image transformations process is carried out with two-dimensional discrete wavelet decomposition level one as shown in Figure 4, it will generate four sub-bands, namely:

- Coefficient Approximation (CA) or LL sub-band.
- Coefficient Horizontal Detail (CH) or HL sub-band.
- Coefficient Vertical Detail (CV) or LH sub-band.
- Coefficient Diagonal Detail (CD) or LH sub-band HH.

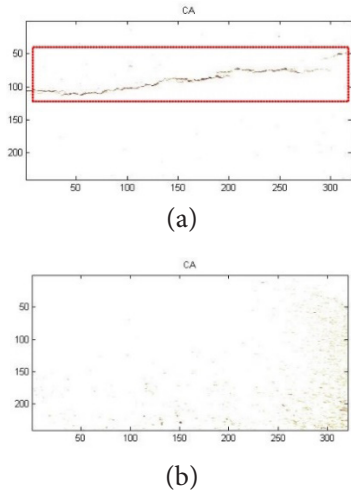
Figure 5. CA transformation result (a) crack images (b) non-crack images.

This algorithm has been applied and produced CA values after decomposition as shown in Figure 5.

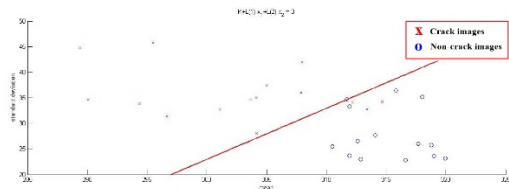
Figure 6. Scatter plot feature extraction (sum-std) and its linear discriminant line.

In the case of mean-STD feature extraction, it shown in Figure 6.

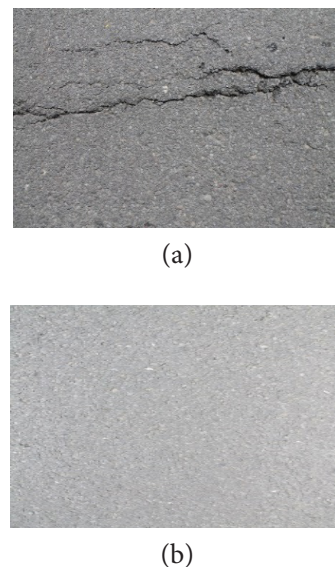
Figure 7. Good quality images (a) crack, (b) non-crack.

A total of 56 testing images were classified by quality into good, medium, and low. This qualification based on manual perception. Good quality images are images that can be processed properly and produce a right decision according to manual classification. It is easy to detect because the images have a high contrast between object and background. The sample of good images is shown in Figure 7.

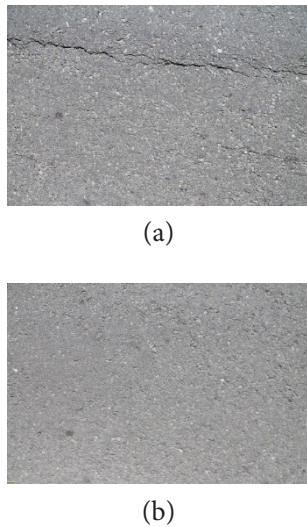
Figure 8. Medium quality images (a) crack, (b) non-crack.

Medium quality images have cracks that less obvious. It is difficult to recognize these images because it has the same color between object and background and non-crack images displays a less smooth. The sample of medium quality images are shown in Figure 8. Bad quality images are images that can't be processed properly and produce a false decision according to manual classification. This image isn't clear with the same color between object and background, so it's difficult recognized. The sample of bad quality images is shown in Figure 9.

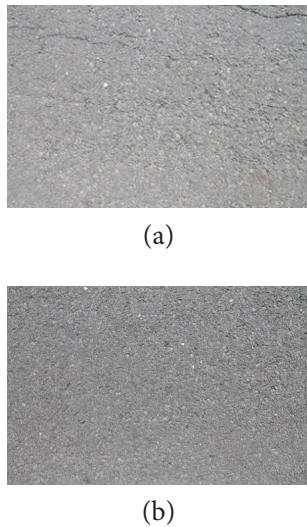
Figure 9. Bad quality images (a) crack, (b) non-crack.

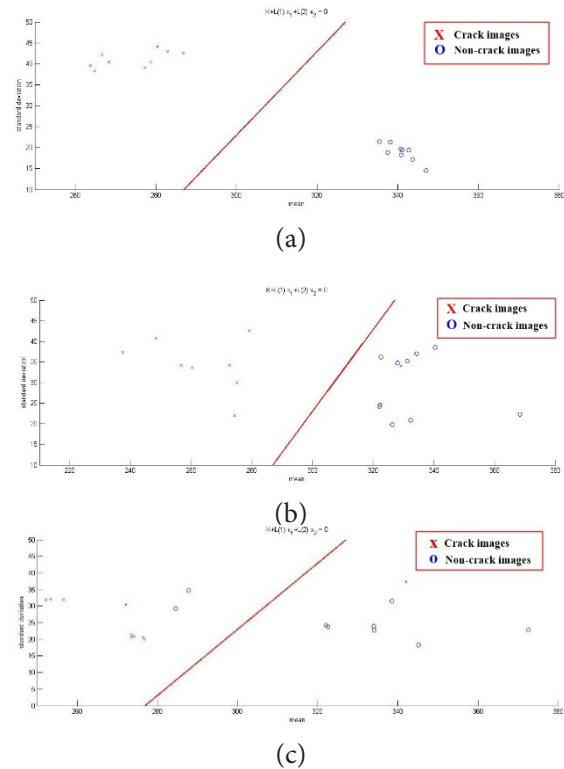
Figure 10. Scatter plot of tested images by quality, (a) good, (b) medium, (c) low.

These images were tested using linear discriminant analysis. The result of tested images is shown in Figure 10.

Scatter plot result quality images are shown in Figure 7 with “x” as crack images and “o” as non-crack. From scattering plot result can be observed that both of crack and non-crack images separated by red lines linear equation. It's mean that testing on good quality images Figure 7(a) scores up to 100% accuracy. Scatter plot of medium-quality images Figure 7(b) can be observed that some

images cross the red lines equation, scores up to 94.7% accuracy. Scatter plot of bad quality images Figure 7(c) can be observed that some images cross the red lines. This type crack and non-crack images difficult to distinguish from the background scores up to 94.7% accuracy. The classification results of 56 testing images filtered by quality; good, medium, and low quality which shown in Table 1.
